Operational Readiness

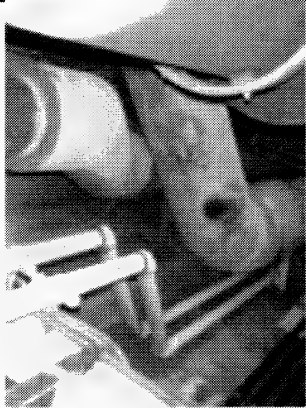
Deck 5 Wheelhouse Top		Funnel Casing				
Inspection Zone	Insulation	Condition	Accessibility	Friability	Recommendation	Picture
Deckhead	Painted metal.

Bulkhead	Perforated metal over man-made mineral fibre insulation.					
Lagging	Man-made mineral fibre insulation (Fibreglass-type) and non-asbestos textile. Cementitious elbows and fittings may contain asbestos. Navy board. High temperature jacketing and metal mesh over man-made mineral fibre insulation.				Maintain in an intact condition. Sample prior to disturbance

Other	Caulking and Penetrations present: may contain older asbestos containing materials below. Possible asbestos sheet gasket material observed.

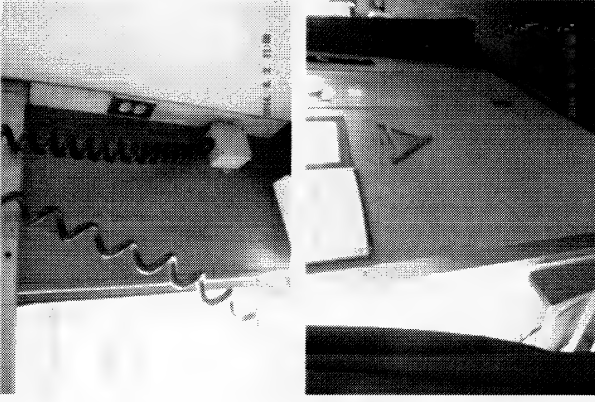
Deck 4 Navigation Bridge Deck			Wheelhouse			
Inspection Zone	Insulation	Condition	Accessibility	Friability	Recommendation	Picture
Deckhead	New non-asbestos marine panels over foil-faced man-made mineral fibre insulation.

Bulkhead	Fwd: Wood panels. Aft (behind cabinet): asbestos containing marine panel Aft center line: non-asbestos marine panel Port & Stbd: Wood panels.	FAIR	HIGH	MEDIUM	Caulk all smaller cracks and joints with fire rated caulking.

Lagging	Pipe lagging and red duct mastic above deckhead panels contains asbestos.

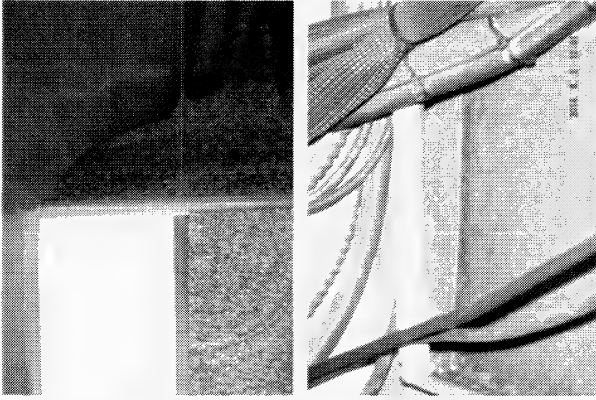
Deck	Carpet over sheet flooring and asbestos tile over asbestos containing deck screed.	GOOD	LOW	LOW	Maintain concealed deck screed if present in an intact condition. Sample screed prior to disturbance.

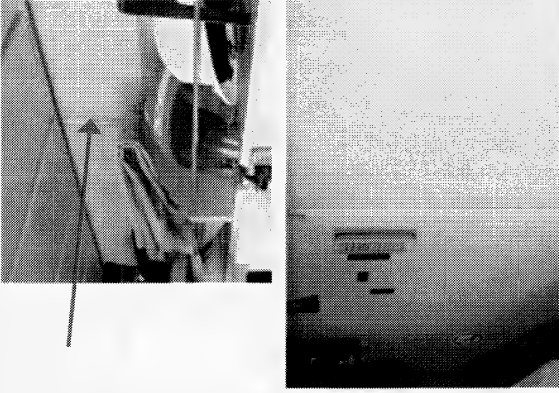
Deck 3 Boat Deck		Chief Officer (B-8)				
Inspection Zone	Insulation	Condition	Accessibility	Friability	Recommendation	Picture
Deckhead	New non-asbestos marine panels over foil-faced man-made mineral fibre insulation.

Bulkhead	Inboard: Asbestos containing marine panels. Rest: New none-asbestos marine panels under windows.	FAIR	HIGH	MEDIUM	Maintain in an intact condition. Sample prior to disturbance.

Lagging	None observed. Pipe lagging and red duct mastic above deckhead panels contains asbestos.					
Deck	Carpet over asbestos tile and/or asbestos containing deck screed.	GOOD	LOW	HIGH	Maintain in an intact condition. Sample prior to disturbance.

Deck 3 Boat Deck		Chief Officer (B-8)
Comments	<p>Recommend installing flashing over seams between marine sheet panels</p>

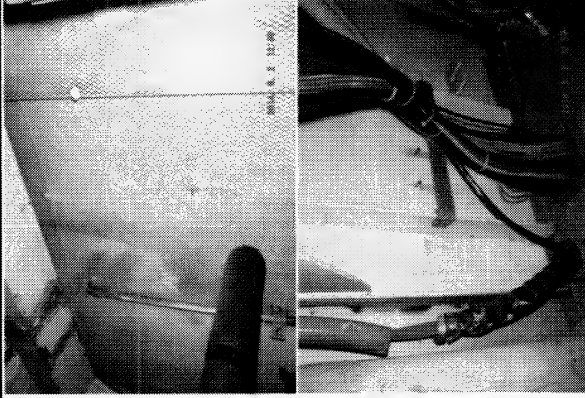
Deck 3 Boat Deck		Fan Room (B9)			
Bulkhead	<p>Inboard and Outboard: Perforated metal over man-made mineral fibre insulation. Rest: Painted metal.</p>

Deck 3 Boat Deck		Fan Room (B9)			
Lagging	Asbestos pipe insulation present. Armaflex insulation on ducts. Man-made mineral fibre insulation (Fibreglass-type). Red duct mastic contains asbestos.	FAIR	MEDIUM	LOW (textile)- HIGH (insulation)	Remove if possible, otherwise maintain in an intact condition.
Deck	Painted metal.				
Other	Caulking and Penetrations present: may contain older asbestos containing materials below

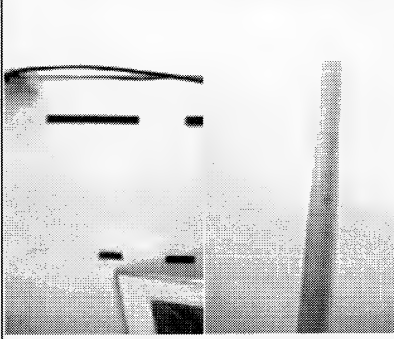
Bulkhead	Asbestos containing marine panels, except under window Note: Liner under window removed during VLE 2009-10	FAIR	HIGH	MEDIUM	Maintain in an intact condition. Sample prior to disturbance.

Lagging	None observed. Pipe lagging and red duct mastic above deckhead panels contains asbestos.				Maintain in an intact condition. Sample prior to disturbance.

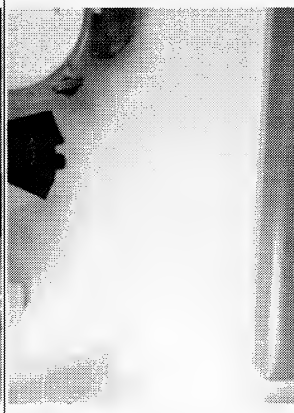
Bulkhead	Asbestos containing marine panels.	Good-Fair	HIGH	MEDIUM	Maintain in an intact condition. Sample prior to disturbance.

Lagging	Post refit: None observed.					
Deck	Carpet over possible asbestos tile and/or deck screed (screed may contain asbestos).				Maintain in an intact condition. Sample prior to disturbance.

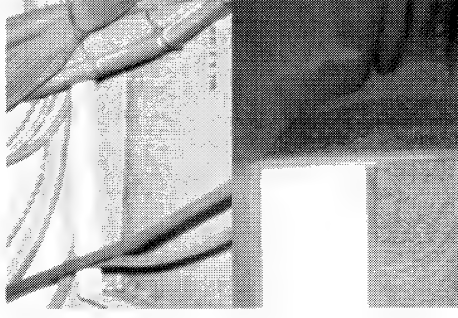
Floor Tile	Floor tile contains asbestos based on sample results: <ul style="list-style-type: none">32927-1: Chief Engineer (B-6) (1% Chrysotile)	Good	Non-friable	A	7	
	Deck screed	Deck screed contains asbestos based on sample results: <ul style="list-style-type: none">16579-1 to 3 Deck screed and brown insulation (NWWest)collected by PEC	Unknown	Non-friable	D	7	
Comments	N/A

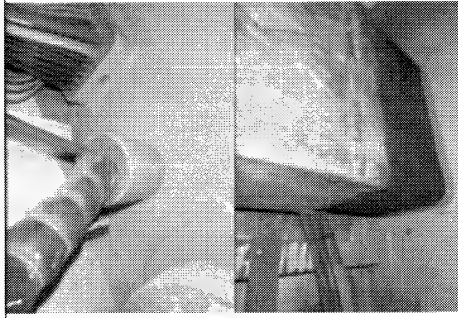
Red duct mastic.	Red duct mastic contains asbestos based on sample results: <ul style="list-style-type: none">collected by PEC	Good	Non-friable	C (concealed)	7			
Comments	N/A

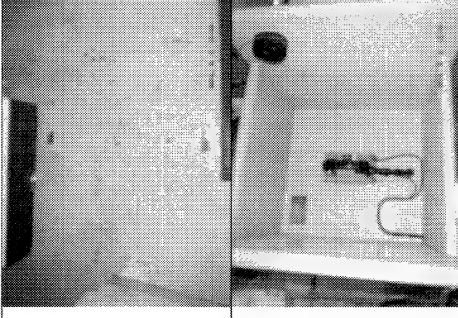
Other	Acoustic phone booth.	Liner or insulation - may contain asbestos.	Unknown	Friable	D	7			
Comments	N/A

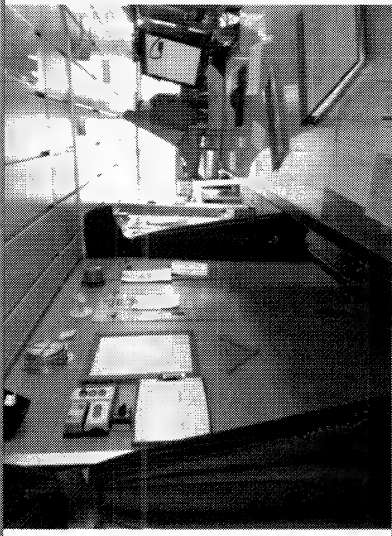
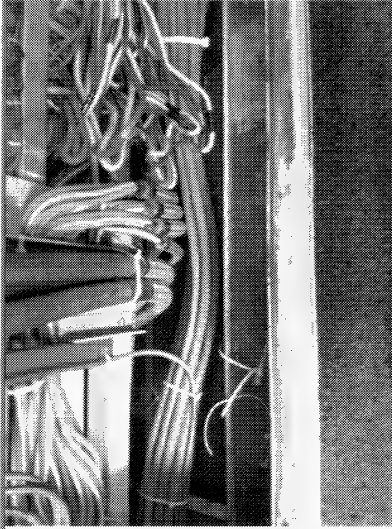
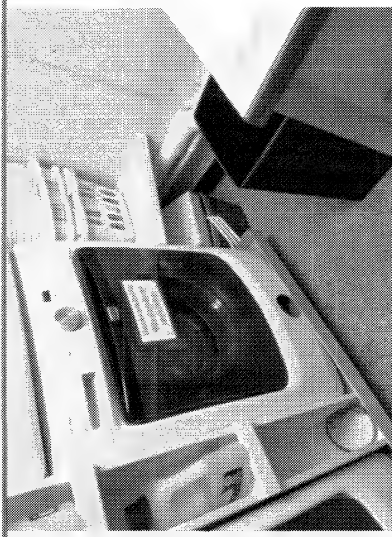
<p>Unit/Location: Wheelhouse Description: Overview Comments: Curtains and other porous items meant for reuse will be HEPA vacuumed, bagged, and laundered. HEPA vacuum and wipe all surfaces.</p>	<p>Unit/Location: Wheelhouse console Description: Overview of typical console Comments: HEPA vacuum accessible surfaces within consoles to remove loosely adhered dust. Do not wet/damp wipe cables.</p>	<p>Unit/Location: Laundry Room Description: Overview Comments: Units are framed into place.</p>

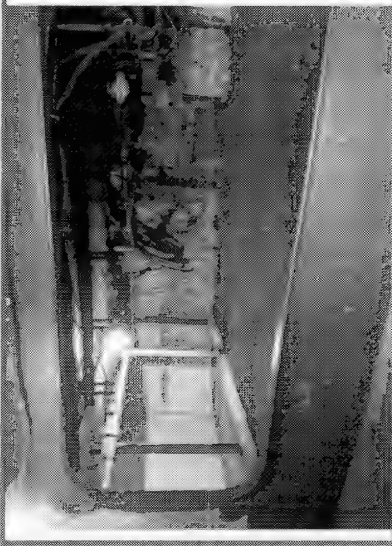
<p>Unit/Location: Void Space Under Wheelhouse</p> <p>Description: Overview</p> <p>Comments: HEPA vacuum and wipe to remove loosely adhered dust.</p>

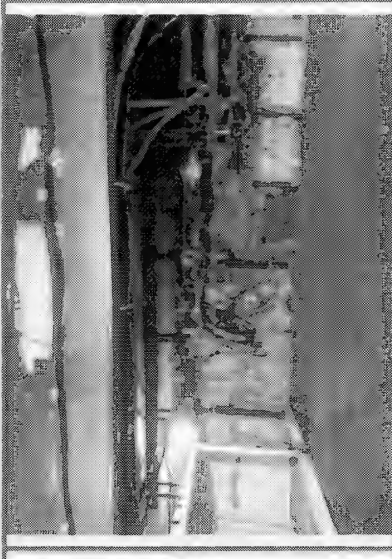
<p>Unit/Location: Void Space Under Wheelhouse</p> <p>Description: Overview</p> <p>Comments: HEPA vacuum and wipe to remove loosely adhered dust. Fibreglass-type insulation present.</p>
 	<p>Unit/Location: MCR</p> <p>Description: Overview</p> <p>Comments: HEPA vacuum accessible surfaces within consoles to remove loosely adhered dust. Do not wet/damp wipe cables.</p>

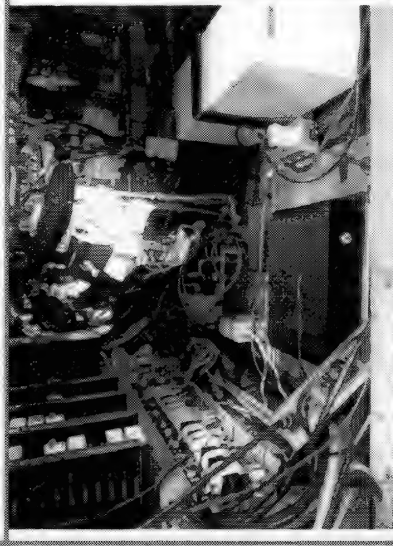
<p>Unit/Location: MCR</p> <p>Description: Overview</p> <p>Comments: HEPA vacuum accessible surfaces within consoles to remove loosely adhered dust. Do not wet/damp wipe cables.</p>

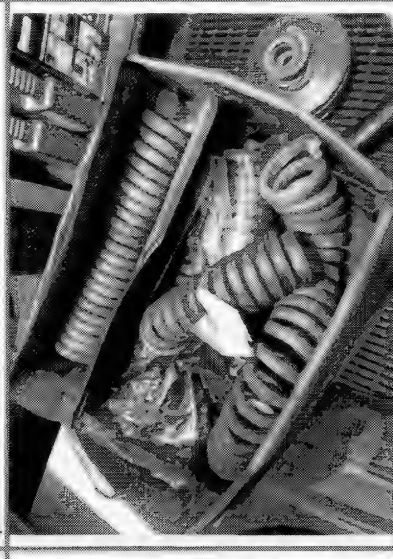
<p>Unit/Location: MCR Stores</p> <p>Description: Asbestos-containing rope gaskets/packing stored exposed.</p> <p>Comments: Dispose of ACM, clean shelving and adjacent surfaces within 2 feet.</p>

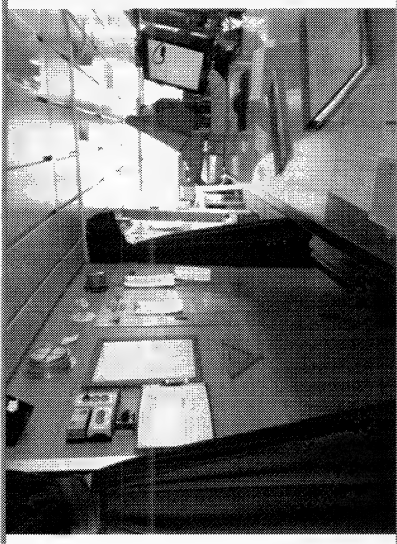
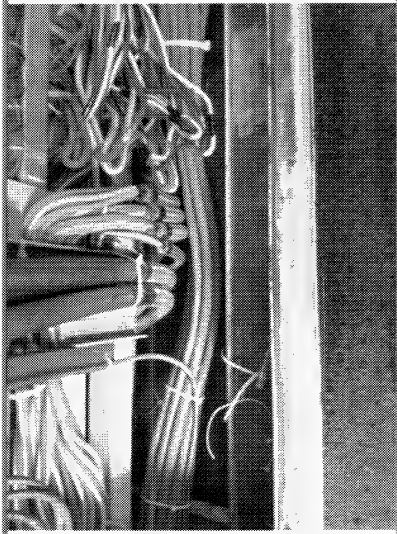
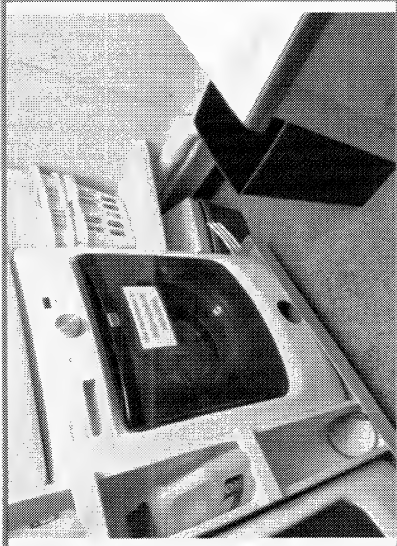
<p>Unit/Location: Wheelhouse Description: Overview Comments: Curtains and other porous items meant for reuse will be HEPA vacuumed, bagged, and laundered. HEPA vacuum and wipe all surfaces.</p>	<p>Unit/Location: Wheelhouse console Description: Overview of typical console Comments: HEPA vacuum accessible surfaces within consoles to remove loosely adhered dust. Do not wet/damp wipe cables.</p>	<p>Unit/Location: Laundry Room Description: Overview Comments: Units are framed into place.</p>

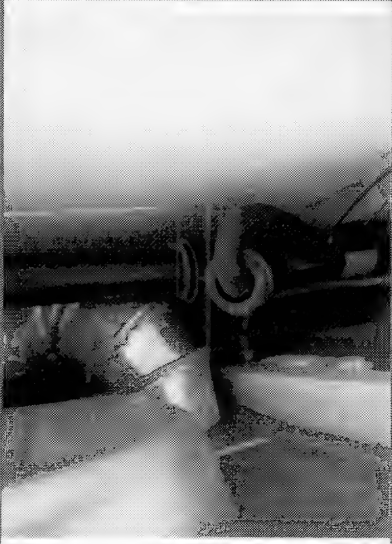
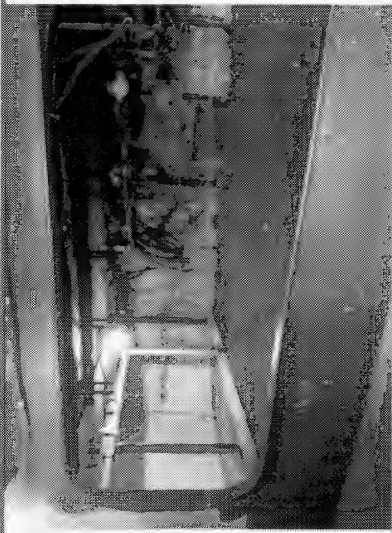
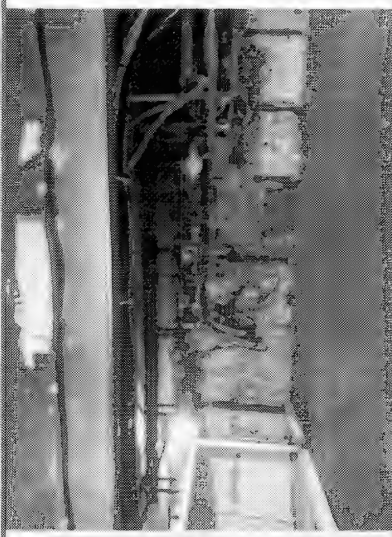
<p>Unit/Location: Laundry Room</p> <p>Description: Dust behind washers and dryers to be cleaned.</p> <p>Comments: Remove units and clean backsides of units and the bulkhead and deck.</p>	<p>Unit/Location: Void Space Under Wheelhouse</p> <p>Description: Overview</p> <p>Comments: HEPA vacuum and wipe to remove loosely adhered dust.</p>	<p>Unit/Location: Void Space Under Wheelhouse</p> <p>Description: Overview</p> <p>Comments: HEPA vacuum and wipe to remove loosely adhered dust. Fibreglass-type insulation present.</p>

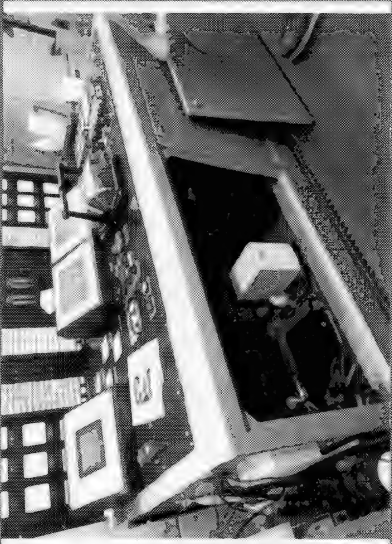
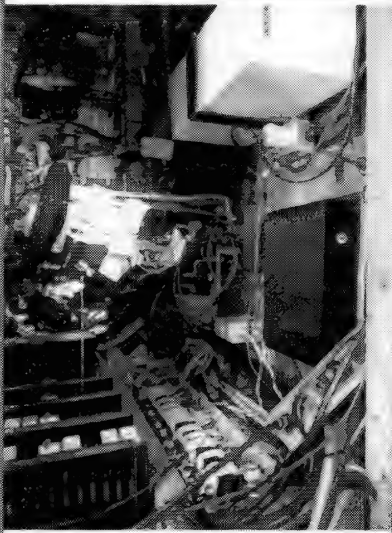
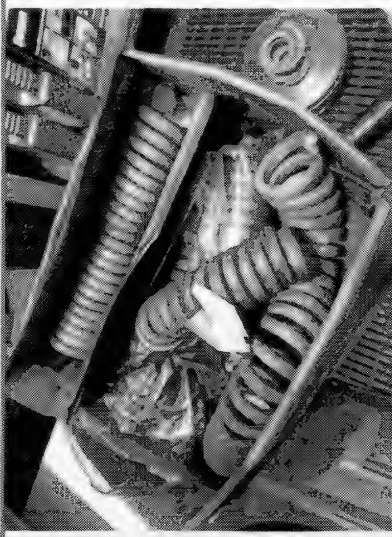
<p>Unit/Location: MCR</p> <p>Description: Overview</p> <p>Comments: HEPA vacuum accessible surfaces within consoles to remove loosely adhered dust.</p> <p>Do not wet/damp wipe cables.</p>	<p>Unit/Location: MCR</p> <p>Description: Overview</p> <p>Comments: HEPA vacuum accessible surfaces within consoles to remove loosely adhered dust.</p> <p>Do not wet/damp wipe cables.</p>	<p>Unit/Location: MCR Stores</p> <p>Description: Asbestos-containing rope gaskets/packing stored exposed.</p> <p>Comments: Dispose of ACM, clean shelving and adjacent surfaces within 2 feet.</p>

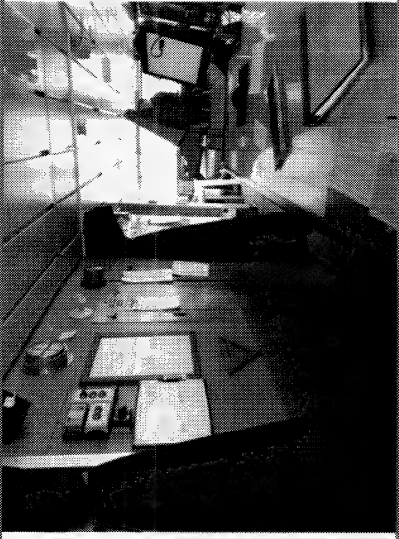
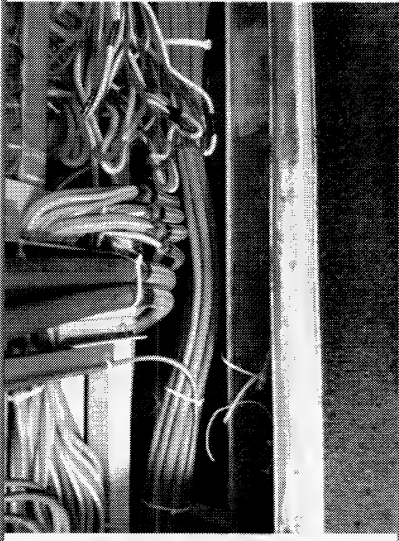
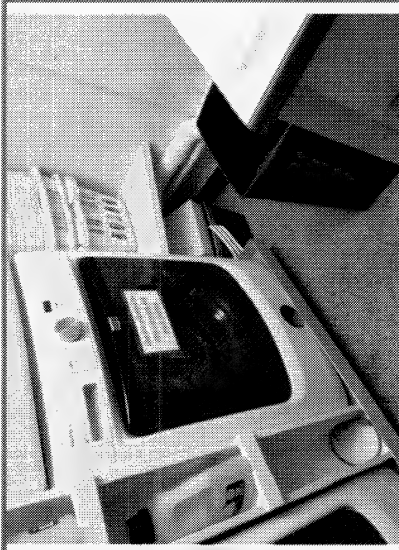
Unit/Location: Wheelhouse Description: Overview Comments: Curtains and other porous items meant for reuse will be HEPA vacuumed, bagged, and laundered. HEPA vacuum and wipe all surfaces.	Unit/Location: Wheelhouse console Description: Overview of typical console Comments: HEPA vacuum accessible surfaces within consoles to remove loosely adhered dust. Do not wet/damp wipe cables.	Unit/Location: Laundry Room Description: Overview Comments: Units are framed into place.

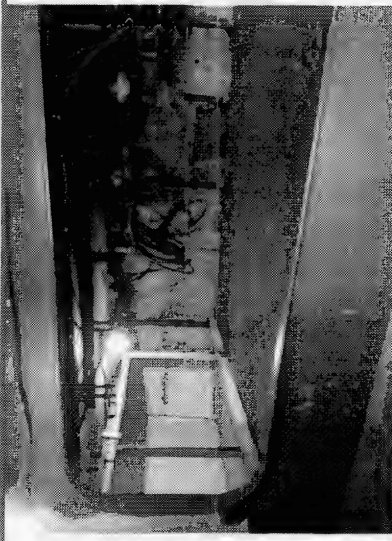
<p>Unit/Location: Laundry Room</p> <p>Description: Dust behind washers and dryers to be cleaned.</p> <p>Comments: Remove units and clean backsides of units and the bulkhead and deck.</p>	<p>Unit/Location: Void Space Under Wheelhouse</p> <p>Description: Overview</p> <p>Comments: HEPA vacuum and wipe to remove loosely adhered dust.</p>	<p>Unit/Location: Void Space Under Wheelhouse</p> <p>Description: Overview</p> <p>Comments: HEPA vacuum and wipe to remove loosely adhered dust. Fibreglass-type insulation present.</p>

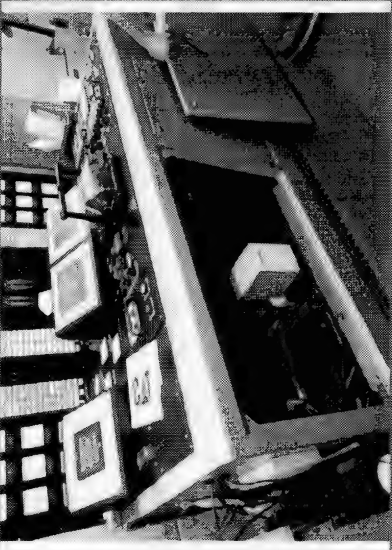
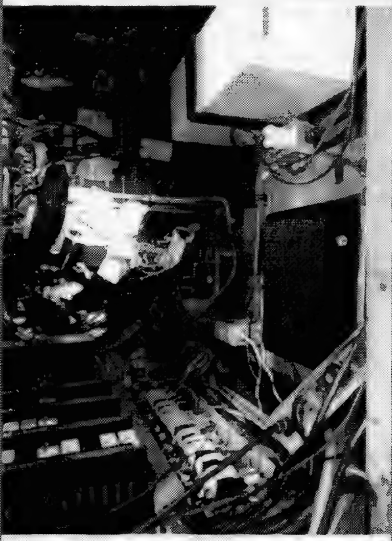
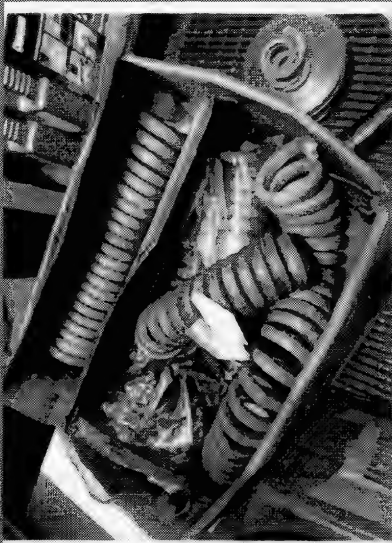
<p>Unit/Location: MCR</p> <p>Description: Overview</p> <p>Comments: HEPA vacuum accessible surfaces within consoles to remove loosely adhered dust. Do not wet/damp wipe cables.</p>	<p>Unit/Location: MCR</p> <p>Description: Overview</p> <p>Comments: HEPA vacuum accessible surfaces within consoles to remove loosely adhered dust. Do not wet/damp wipe cables.</p>	<p>Unit/Location: MCR Stores</p> <p>Description: Asbestos-containing rope gaskets/packing stored exposed.</p> <p>Comments: Dispose of ACM, clean shelving and adjacent surfaces within 2 feet.</p>

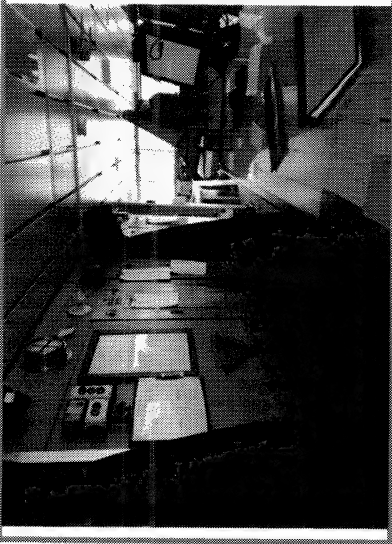
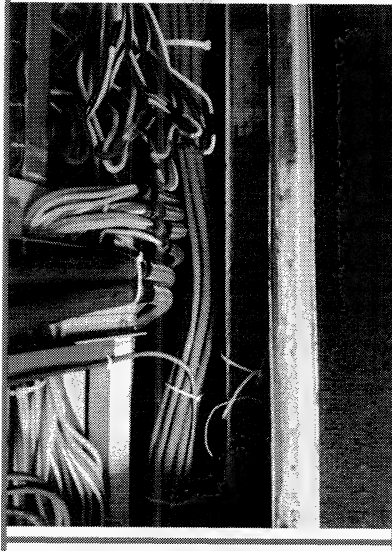
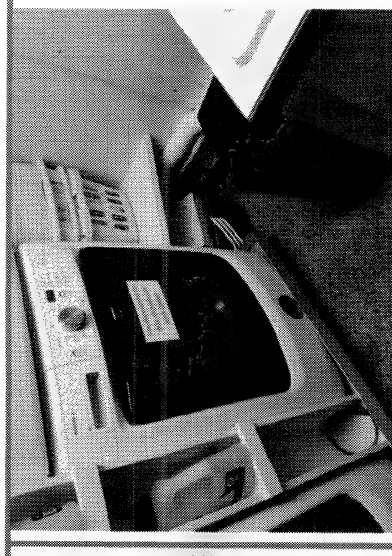
<p>Unit/Location: Wheelhouse</p> <p>Description: Overview</p> <p>Comments: Curtains and other porous items meant for reuse will be HEPA vacuumed, bagged, and laundered. HEPA vacuum and wipe all surfaces.</p>	<p>Unit/Location: Wheelhouse console</p> <p>Description: Overview of typical console</p> <p>Comments: HEPA vacuum accessible surfaces within consoles to remove loosely adhered dust. Do not wet/damp wipe cables.</p>	<p>Unit/Location: Laundry Room</p> <p>Description: Overview</p> <p>Comments: Units are framed into place.</p>

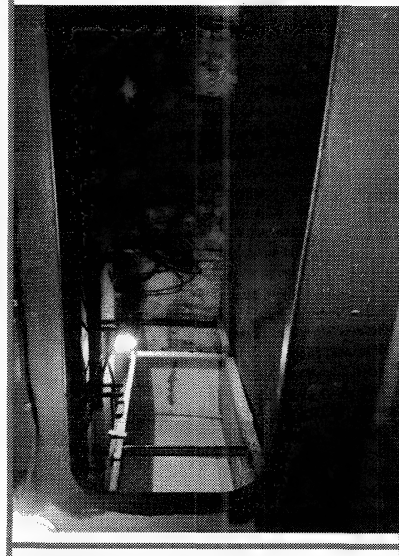
<p>Unit/Location: Void Space Under Wheelhouse</p> <p>Description: Overview</p> <p>Comments: HEPA vacuum and wipe to remove loosely adhered dust.</p>

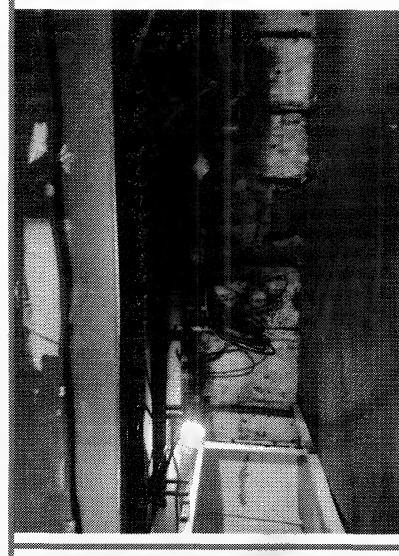
<p>Unit/Location: Void Space Under Wheelhouse</p> <p>Description: Overview</p> <p>Comments: HEPA vacuum and wipe to remove loosely adhered dust. Fibreglass-type insulation present.</p>

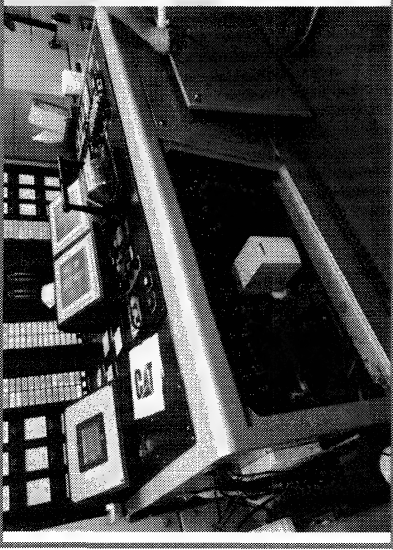
<p>Unit/Location: MCR</p> <p>Description: Overview</p> <p>Comments: HEPA vacuum accessible surfaces within consoles to remove loosely adhered dust. Do not wet/damp wipe cables.</p>

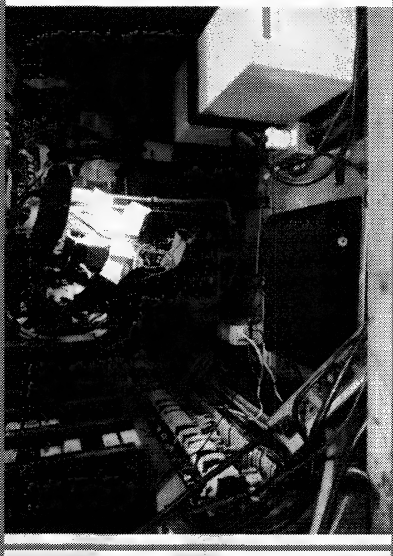
<p>Unit/Location: MCR</p> <p>Description: Overview</p> <p>Comments: HEPA vacuum accessible surfaces within consoles to remove loosely adhered dust. Do not wet/damp wipe cables.</p>

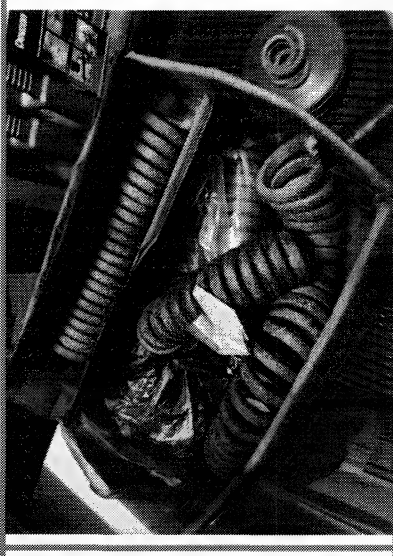
<p>Unit/Location: MCR Stores</p> <p>Description: Asbestos-containing rope gaskets/packing stored exposed.</p> <p>Comments: Dispose of ACM, clean shelving and adjacent surfaces within 2 feet.</p>
